# Manhole Inspection Summary

Manhole # S21K\_\_017MH

Insp Date: **9/25/07 12:58 PM**

**Location** Address: **1822 DOVER-MCHENRY**

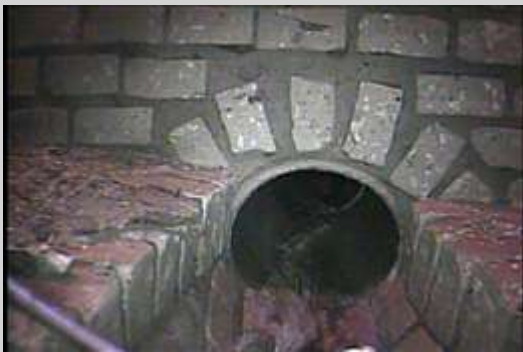
12 O'Clock Outflow

8 in. Circular Gravity Sewer  
Pipe Out @ 12 O'Clock

Pipe Height: **8.4** (in.) Rod and Bar (Angled)  
Pipe Material: **Clay** ☐ Pipe Lined  
Invert Depth: **13.94** (ft.) Flow Characteristics: **Slow**  
Deposits: ☒ None ☐ Mud ☐ Sludge ☐ **Debris** ☐ Grease  
Silt Depth: (in.) Deposits Extent:  
Infiltration: **None** Pipe Seal Cond: **Sound**

Drop: **None**
